LETTER REPORT
FOR
DAELYTE SERVICE COMPANY
DETROIT, WAYNE COUNTY, MICHIGAN
TDD S05-9712-003
PAN 7D0301SIXX

February 19, 1998

Re: Daelyte Service Company
Detroit, Wayne County, Michigan
TDD S05-9712-003
PAN 7D0301SIXX

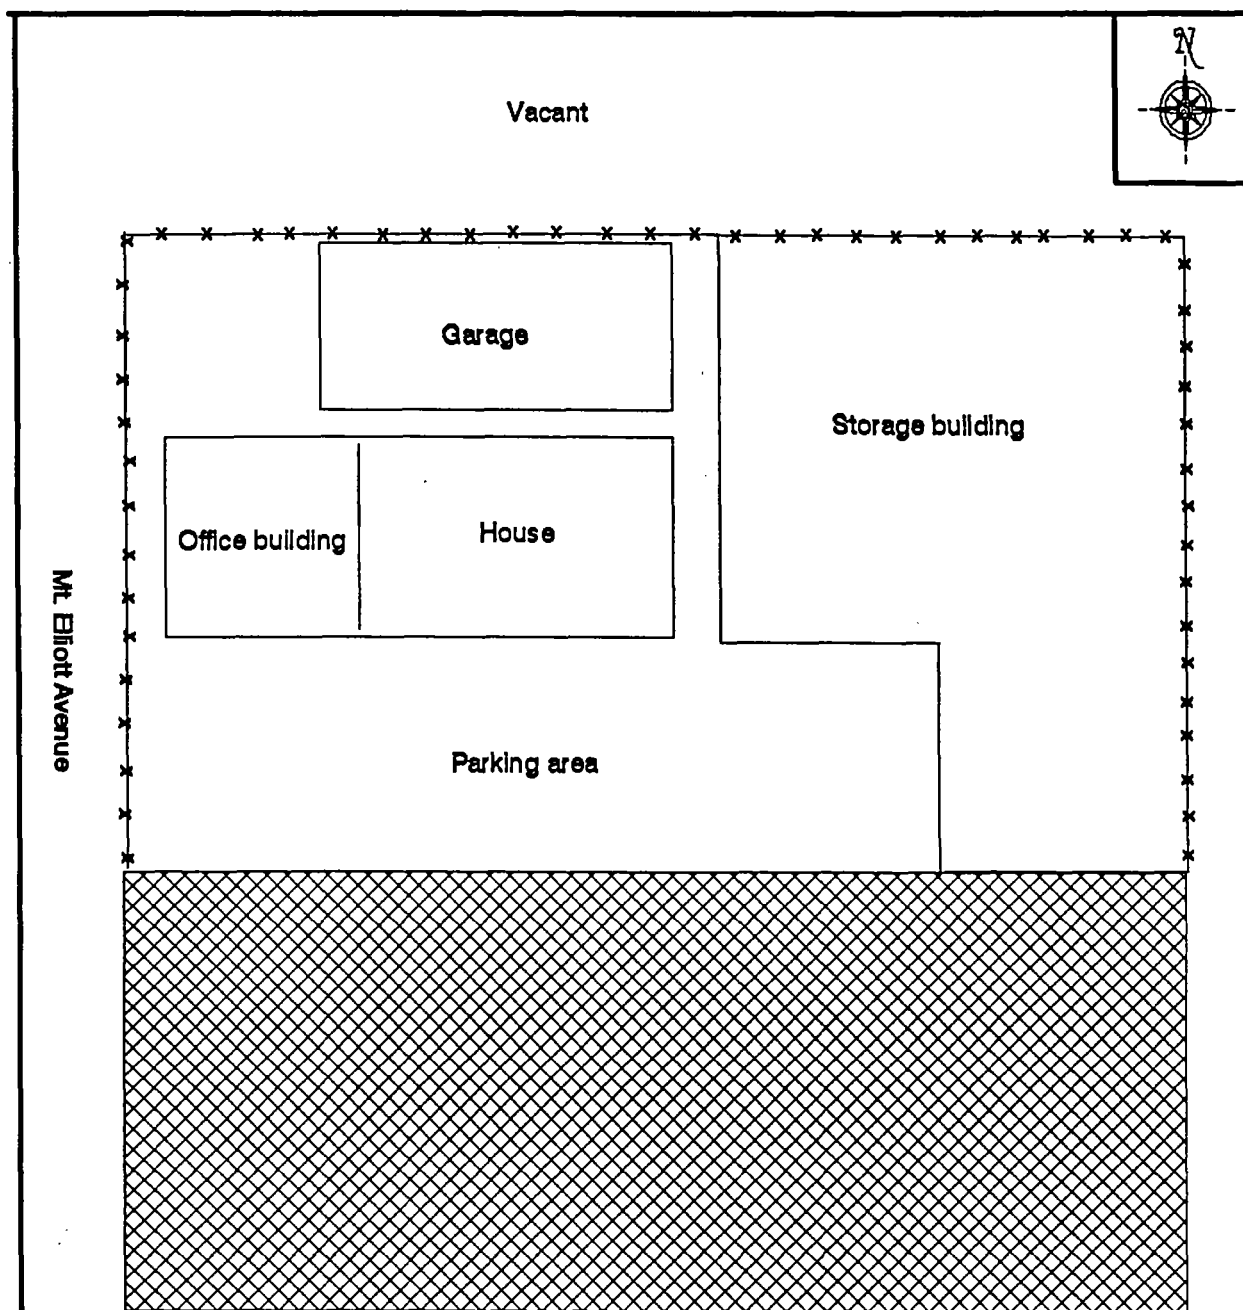
Legend Adjacent building Chain-link fence	ecology and environment, Inc. Superfund Technical Assessment and Response Team Region 5		
	TITLE Site Features Map		FIGURE 2
	SITE Daelyte Service Company		SCALE Not to scale
SOURCE/DATE Ecology and Environment, Inc. January 7, 1998	CITY Detroit	STATE Michigan	TDD S05-9712-003

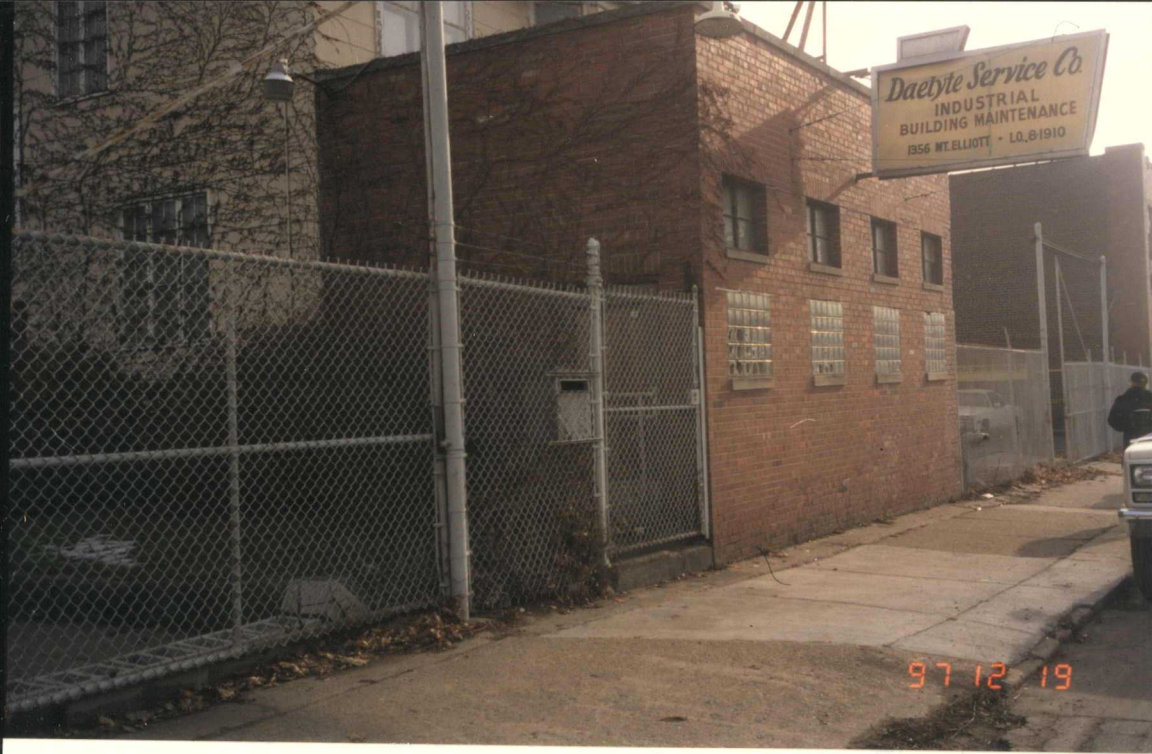
Daelyte Service Co.
 (F1)
 East
 Mt. Elliott

Date: December 19, 1997
Subject: Daelyte Services Co., site located at 1356 Mt. Elliott Avenue.

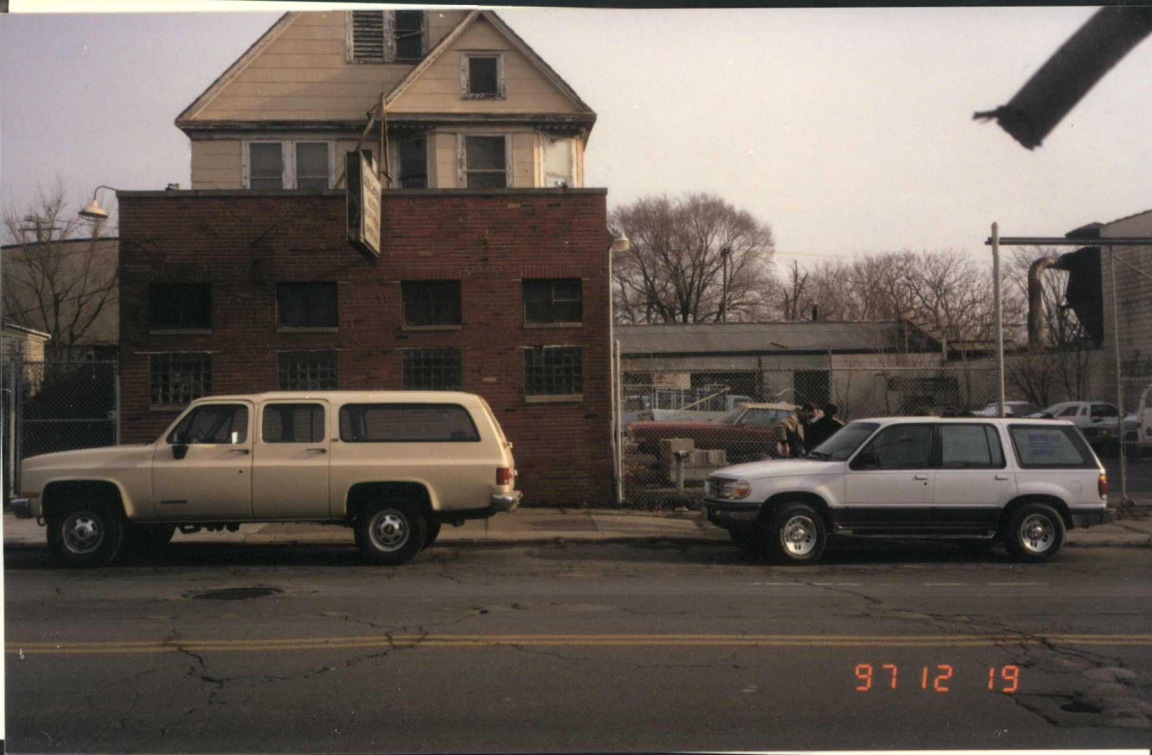
Daelyte Service Co.
 (F2)
 Mt. Elliott

Date: December 19, 1997
Subject: West side of site bordering Mt. Elliott Avenue.

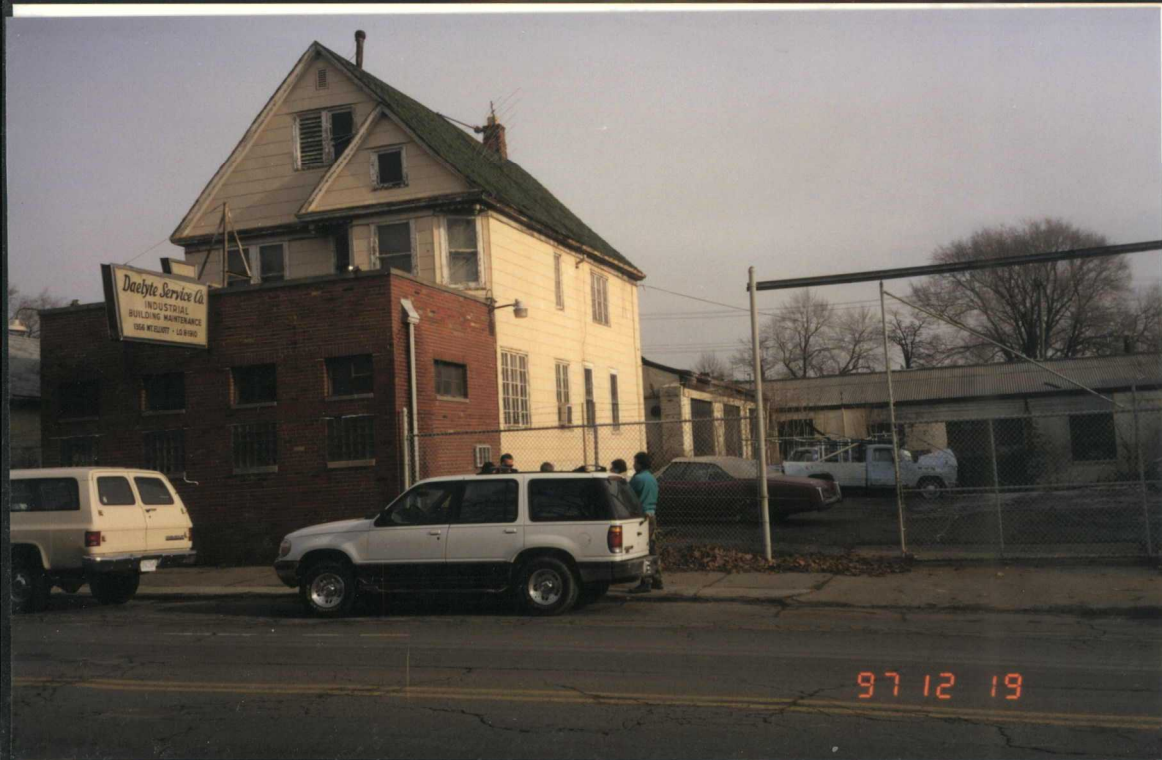
Site: Daelyte Service Co.
Photo No: 3 (R1F3)
Direction: Northeast
Photographer: C. Elliott

Subject: West side of site and parking area storage building.

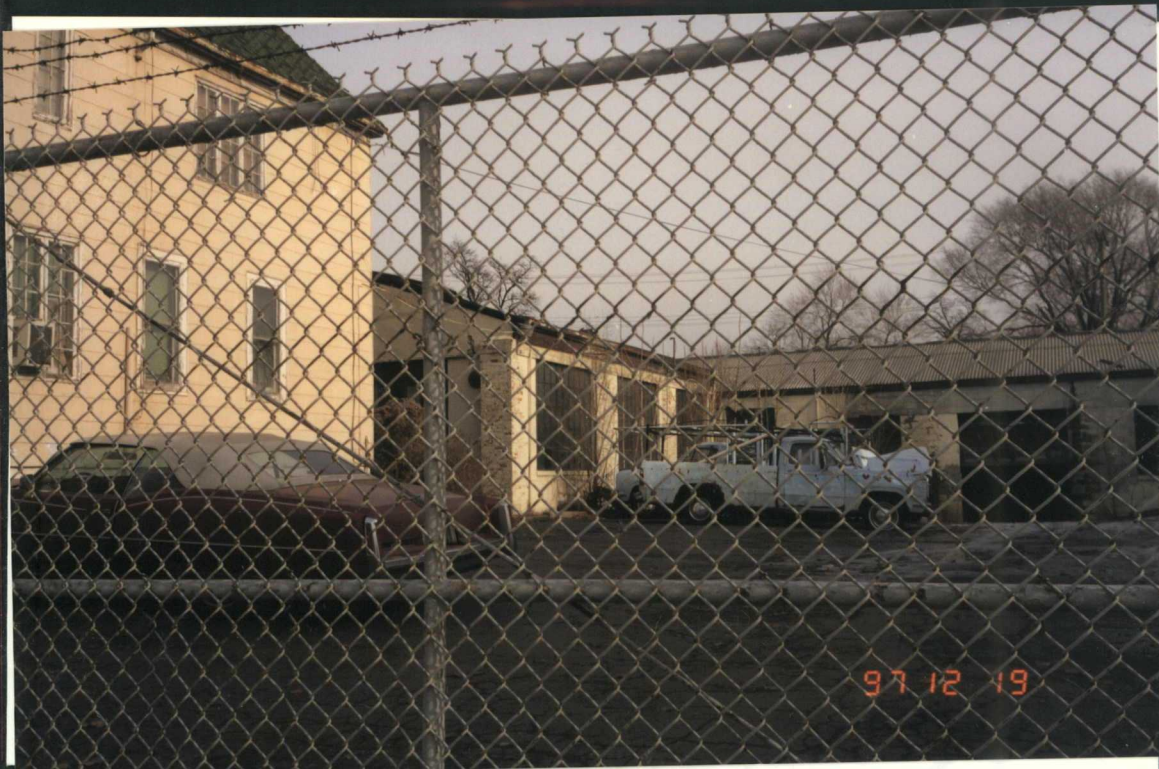
Site: Daelyte Service Co.
Photo No: 4 (R1F4)
Direction: Northeast
Photographer: C. Elliott

Subject: A view of site entrance.

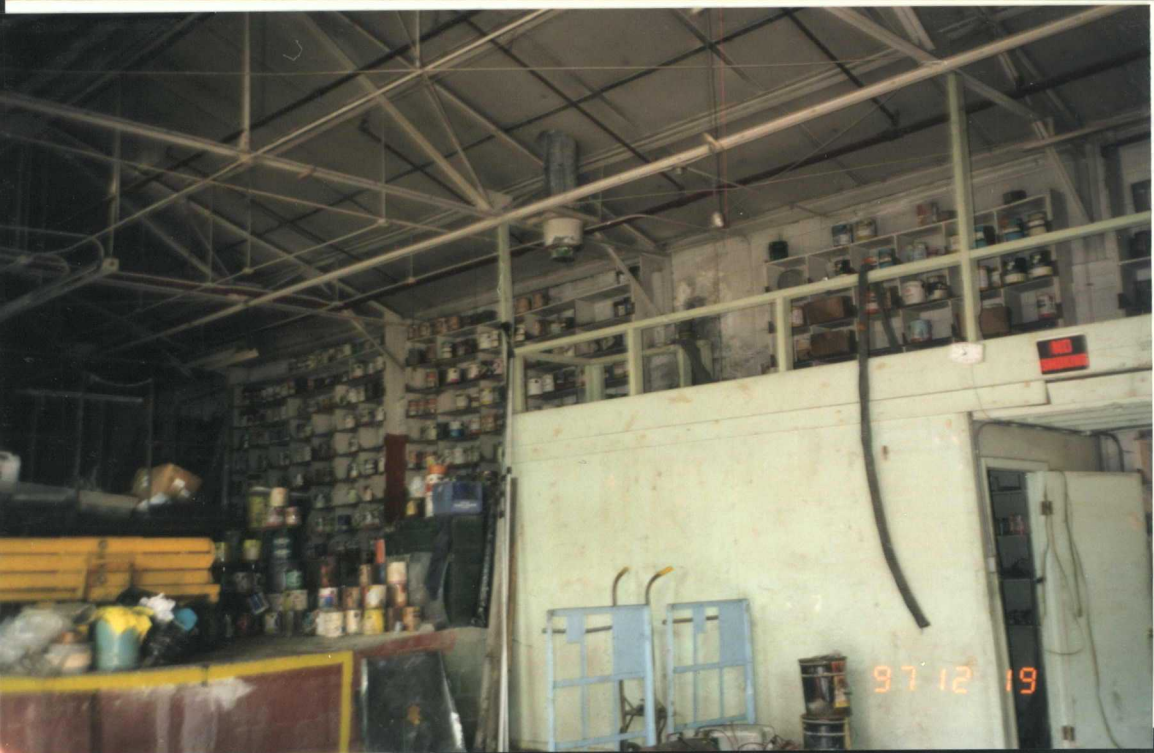
e Co.
(B)
t
C. Elliott

Subject: One-gallon cans stacked on floor and on eastern wall of southeast room and garage room.

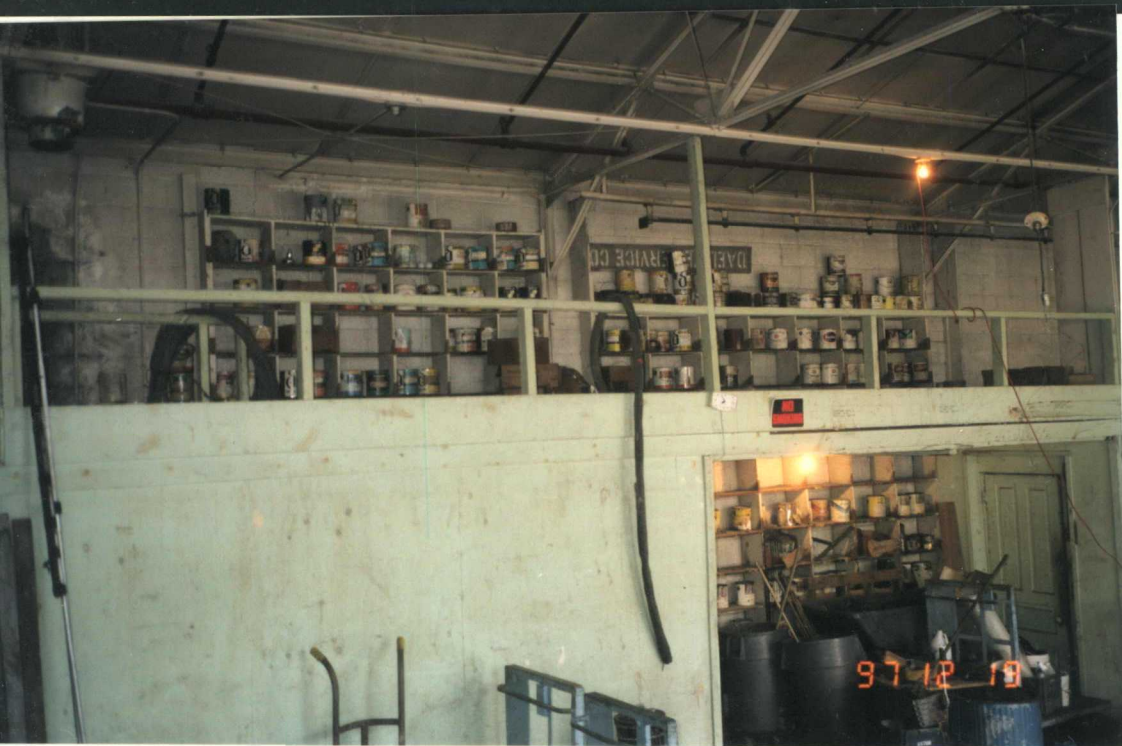
Service Co.
(F12)
theast
C. Elliott

Subject: One-gallon cans on eastern wall of garage room.

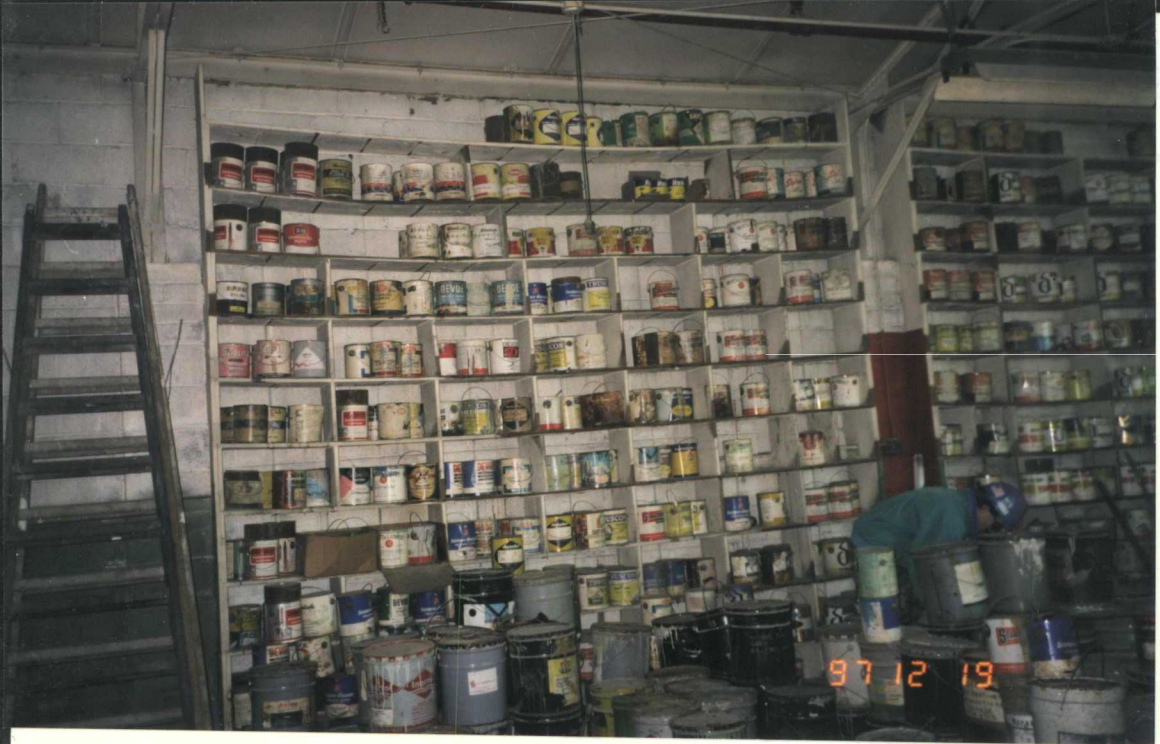
Site: Daelyte Service Co.
Photo No: 7 (R1F10)
Direction: East
Photographer: C. Elliott

Subject: One-gallon cans on eastern wall drums stacked on floor of southeast room

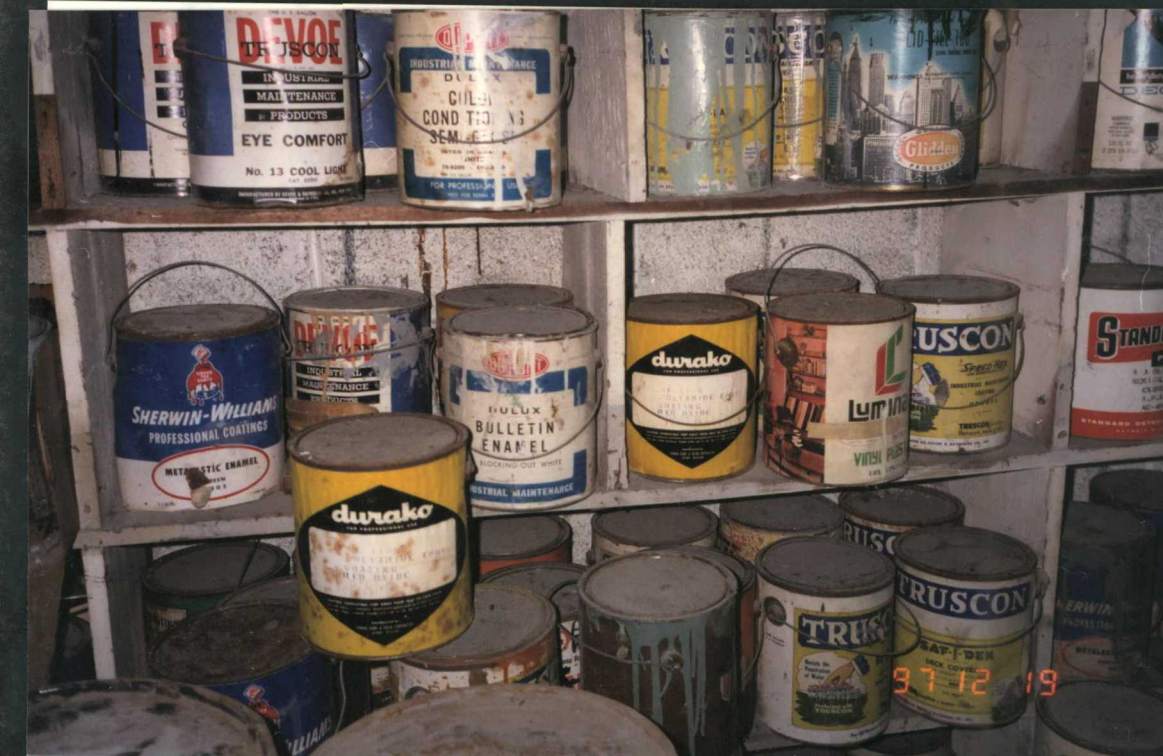
Site: Daelyte Service Co.
Photo No: 8 (R1F13)
Direction: East
Photographer: C. Elliott

Subject: One-gallon cans with manufacturer labels in southeast room.

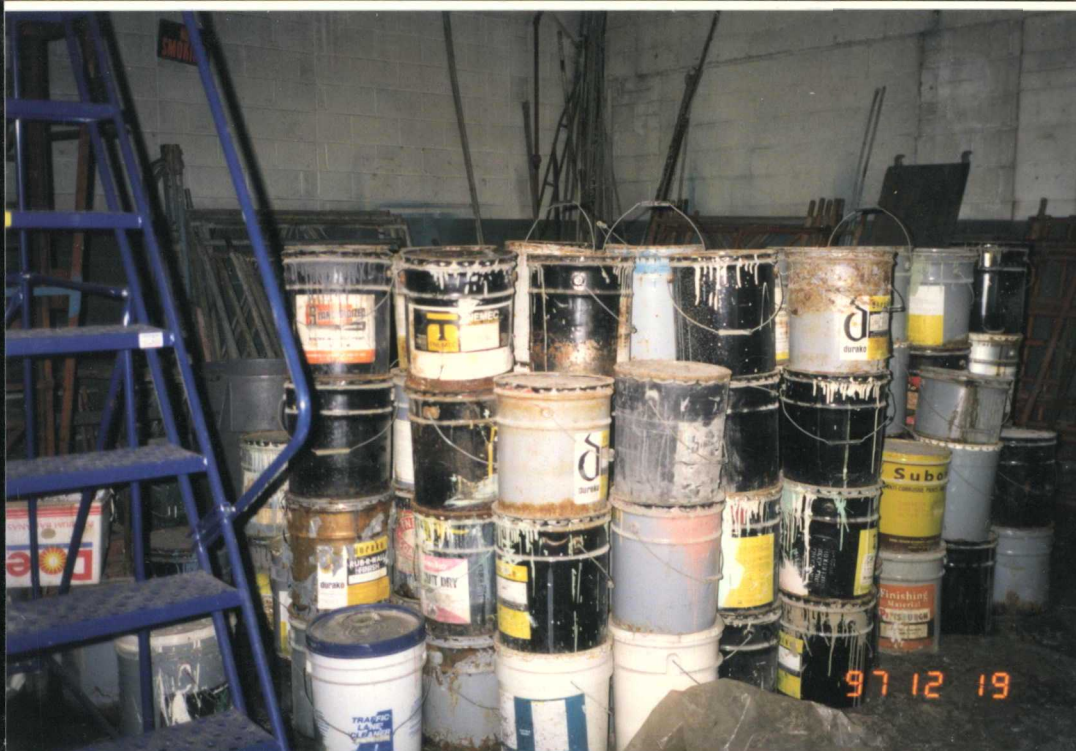
Site: Daelyte Service Co.
Photo No: 9 (R1F11)
Direction: East
Photographer: C. Elliott

Date: December 19, 1997
Subject: Five-gallon drums stacked on floor in southeast room.

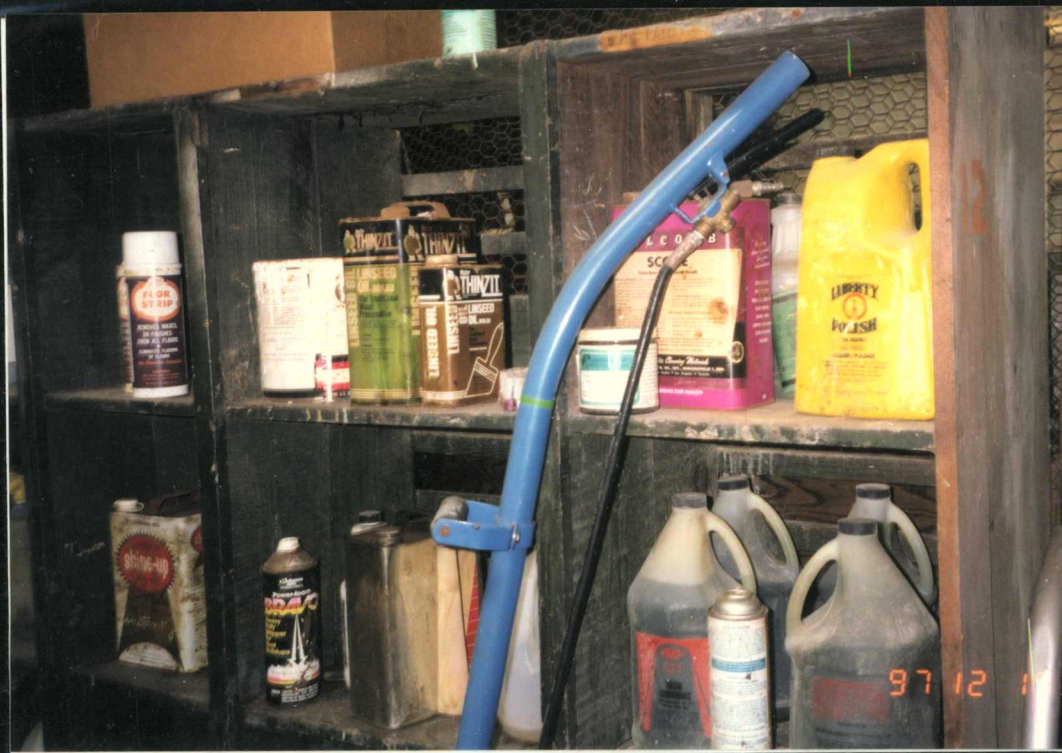
Site: Daelyte Service Co.
Photo No: 10 (R1F9)
Direction: Southeast
Photographer: C. Elliott

START conducted field pH measurements using pH paper. Contents of one 55-gallon steel drum with a polyethylene inner liner and one small container with phosphoric acid label had pH measurements of 1 standard unit.

Date: December 19, 1997
Subject: Four 1-gallon containers, at bottom right, containing material with a pH measurement of 1 standard unit in northern northeast room.

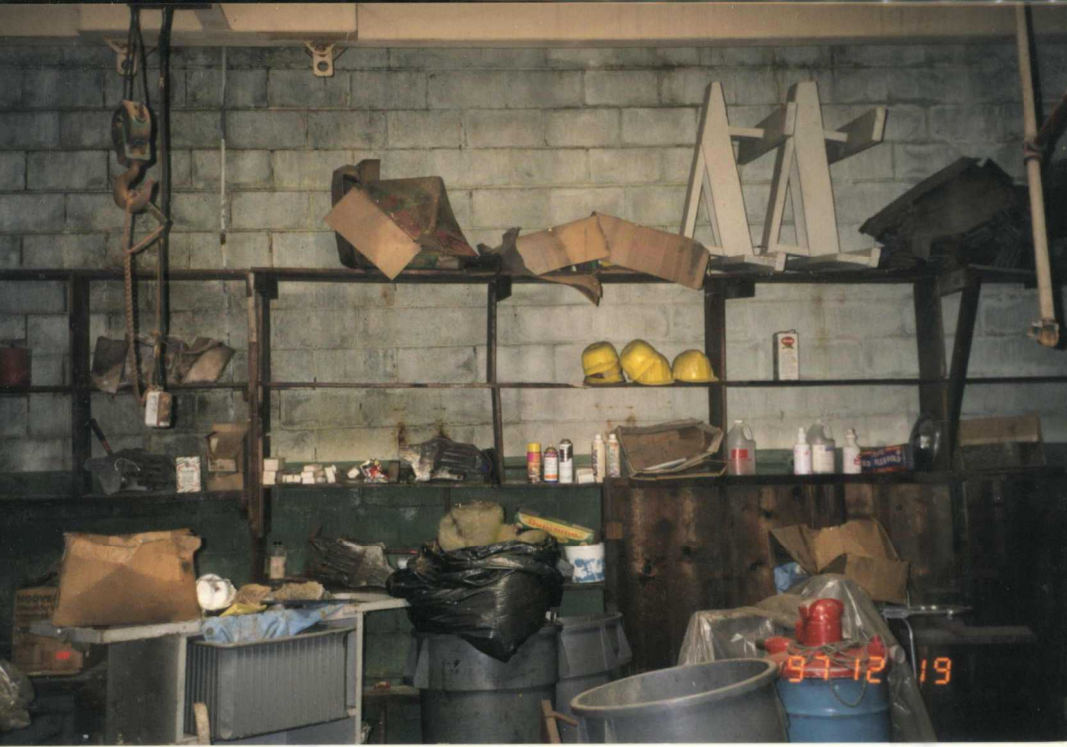
Site: Daelyte Service Co.
Photo No: 11 (R1F8)
Direction: East
Photographer: C. Elliott

Date: December 19, 1997
Subject: Small containers and debris on site.

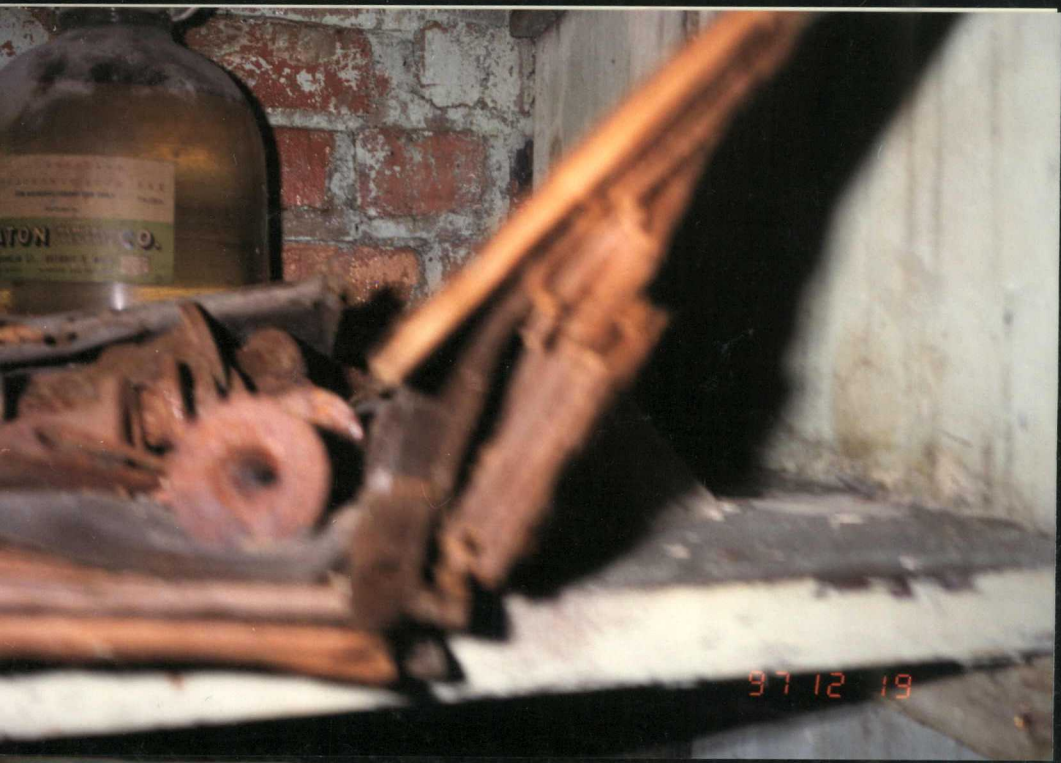
Site: Daelyte Service Co.
Photo No: 12 (R1F14)
Direction: North
Photographer: C. Elliott

Date: December 19, 1997
Subject: One-gallon container with "acid" label in southeast room.

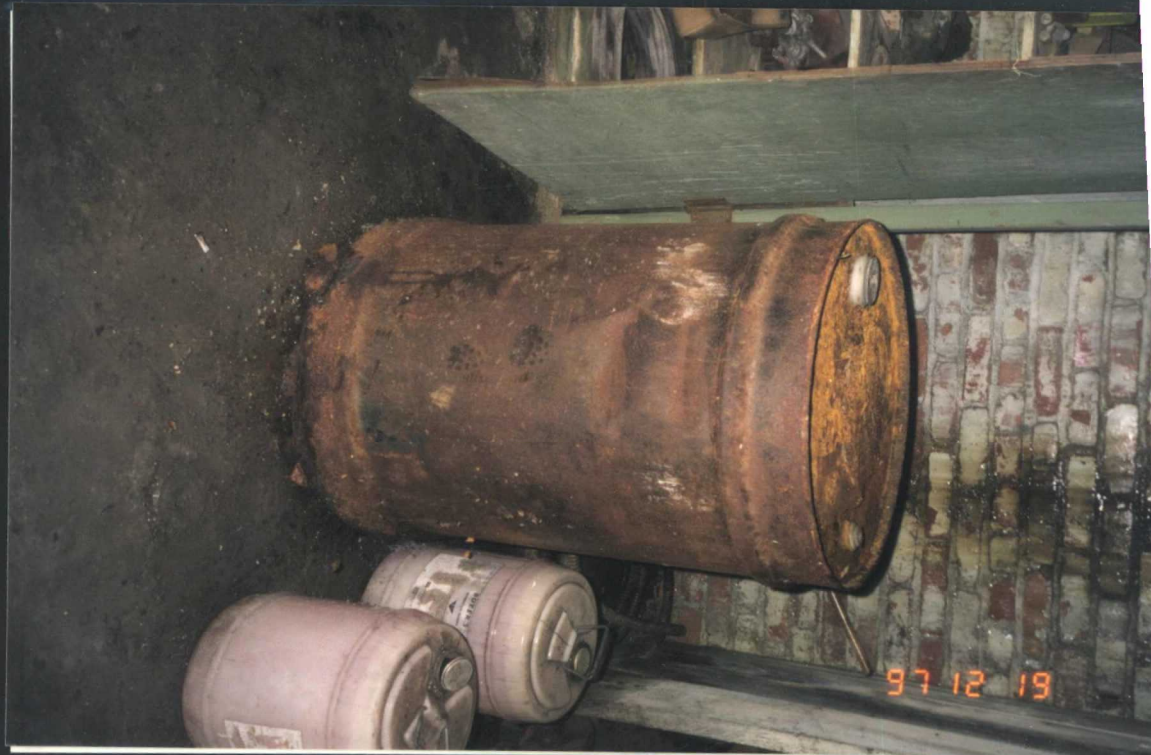
Site: Daelyte Service Co.
Photo No: 13 (R1F16)
Direction: North
Photographer: C. Elliott

Date: December 19, 1997
Subject: Fifty-five-gallon drum containing liquid with pH measurement of 1 standard unit in western room.

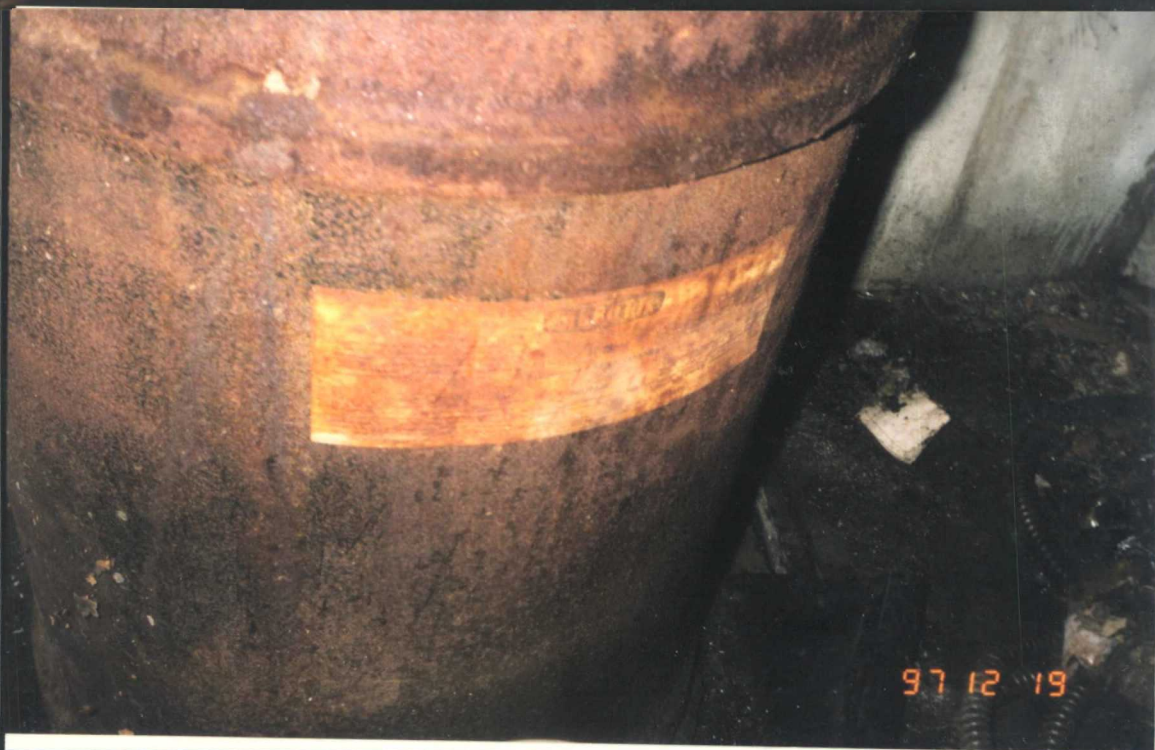
Site: Daelyte Service Co.
Photo No: 14 (R1F15)
Direction: N/A
Photographer: C. Elliott

Date: December 19, 1997
Subject: Label on drum containing liquid with pH measurement of 1 standard unit in western room.

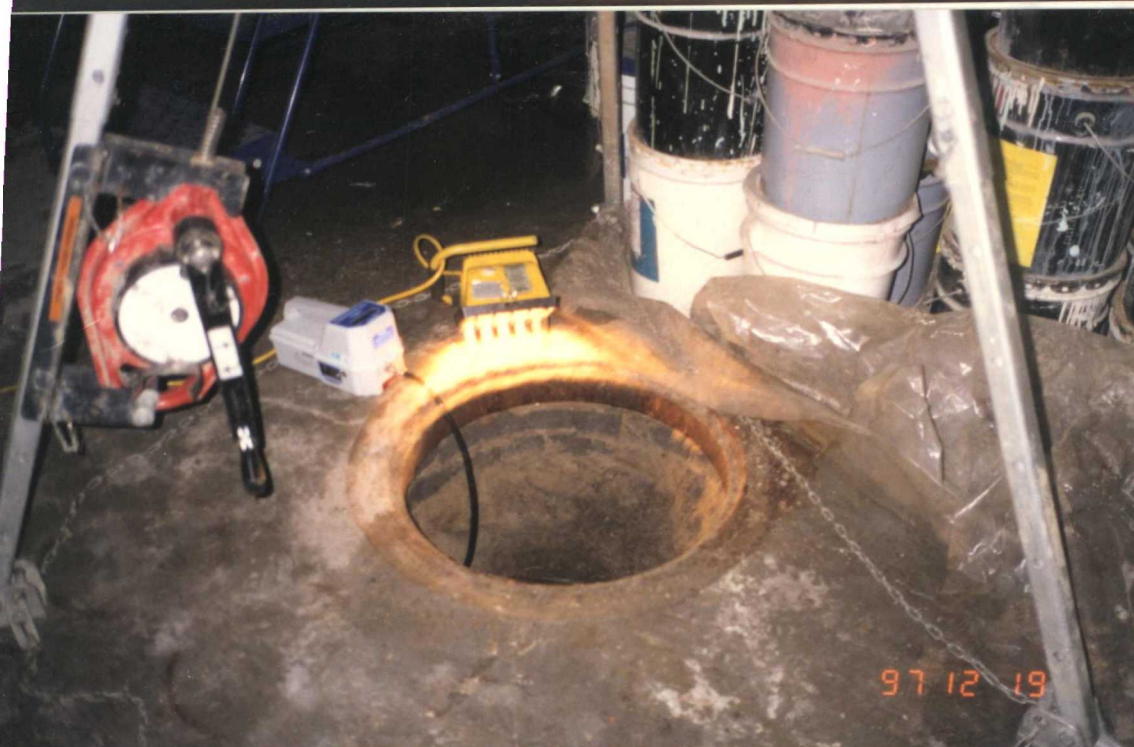
Site: Daelyte Service Co.
Photo No: 15 (R1F17)
Direction: Northwest
Photographer: C. Elliott

Date: December 19, 1997
Subject: Manhole containing UST pipe in southeast room.

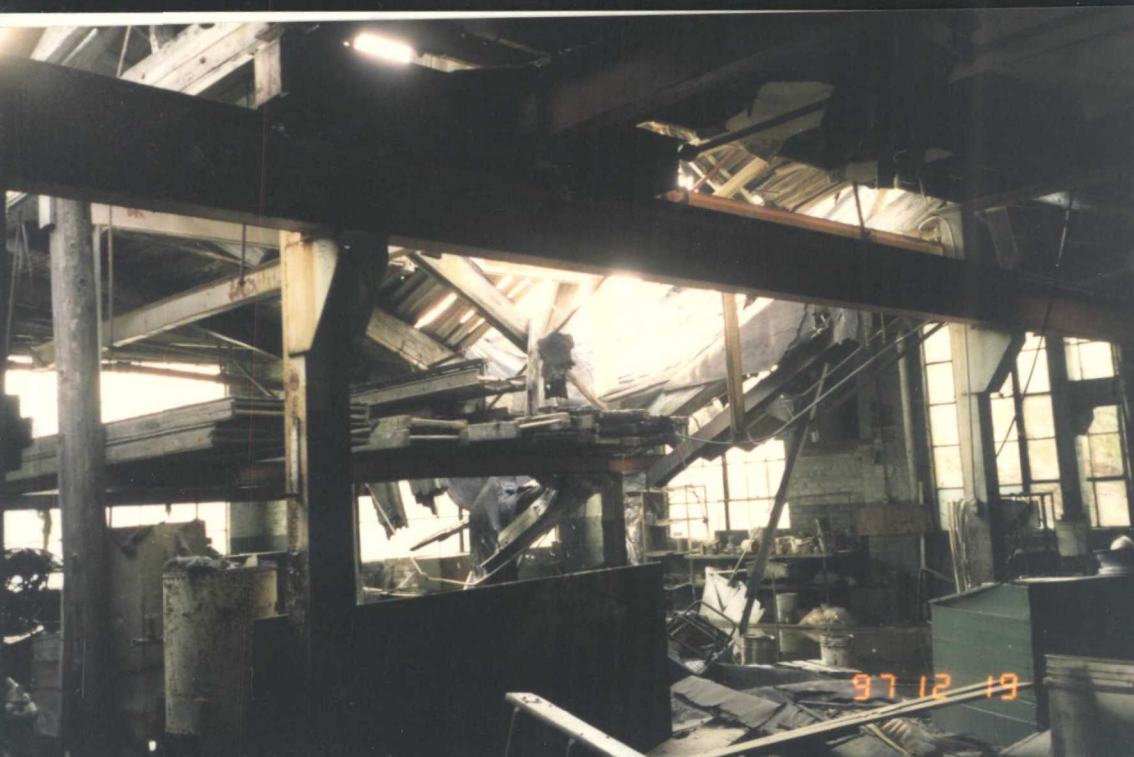
Site: Daelyte Service Co.
Photo No: 16 (R1F5)
Direction: Northwest
Photographer: C. Elliott

Date: December 19, 1997
Subject: Area in western room where roof has collapsed.

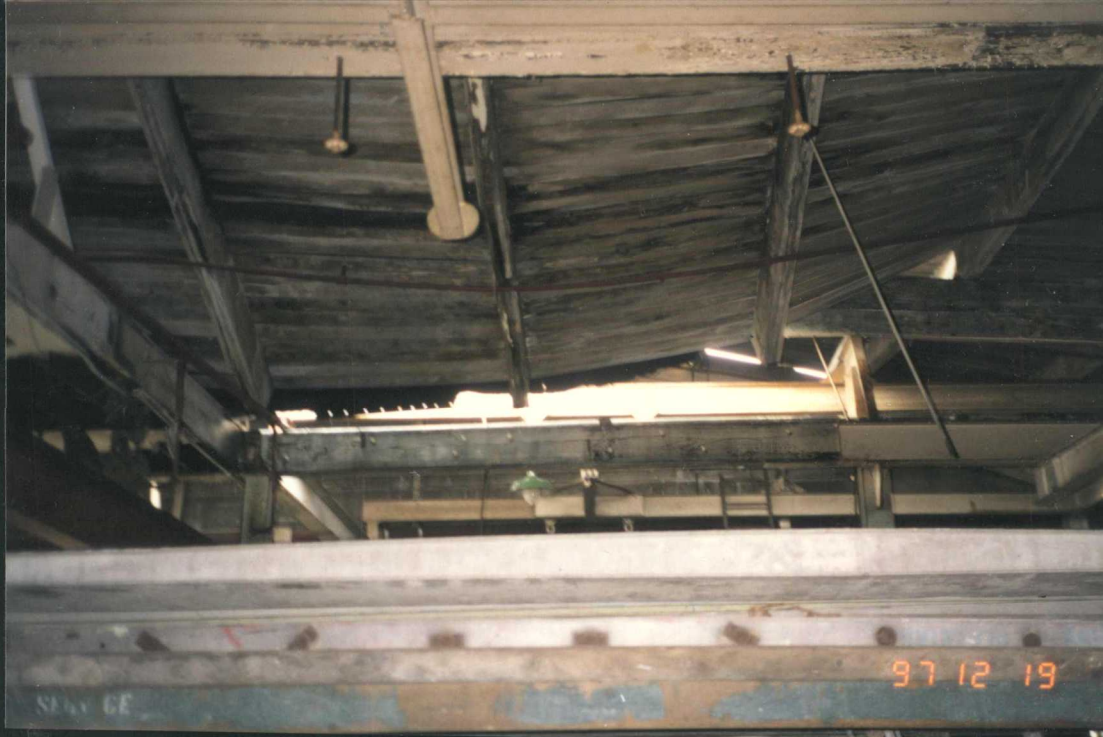
Site: Daelyte Service Co.
Photo No: 17 (R1F7)
Direction: N/A
Photographer: C. Elliott

Date: December 19, 1997
Subject: Hole in roof of the western room.

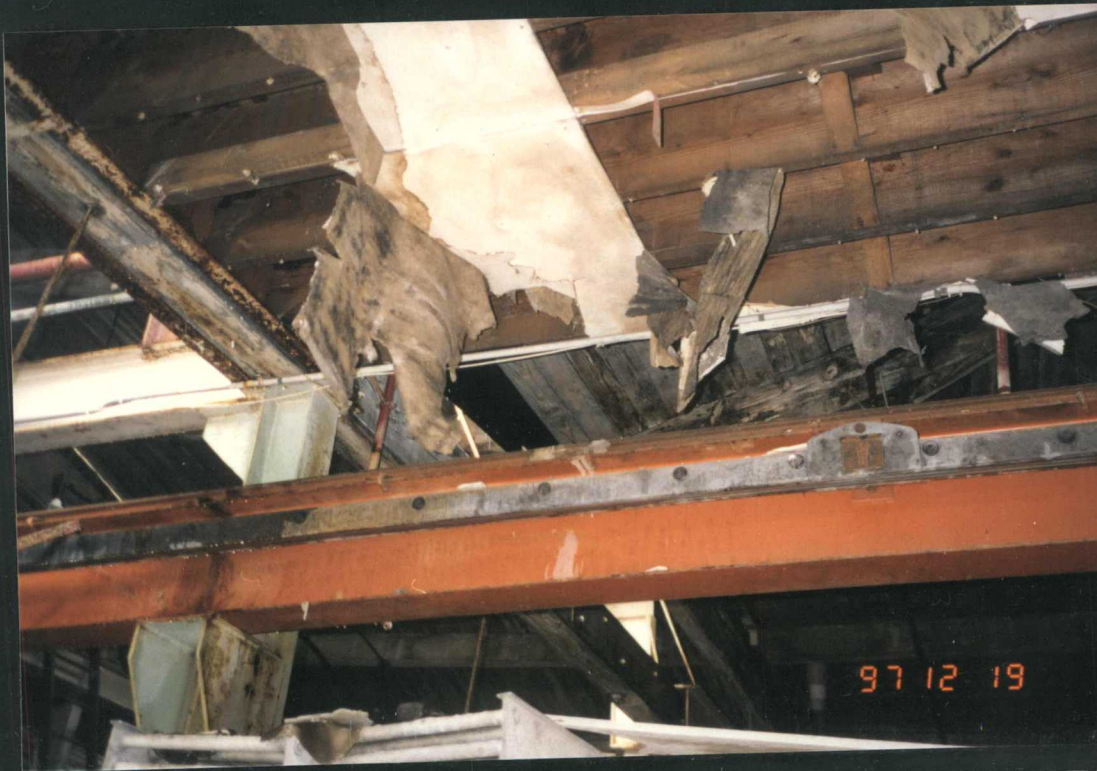
Site: Daelyte Service Co.
Photo No: 18 (R1F6)
Direction: N/A
Photographer: C. Elliott

Date: December 19, 1997
Subject: Hole in roof of the western room.
